Appendix II: Berm Breakwaters

S. Sigurdarson¹, O.B. Smarason² and G. Viggosson¹

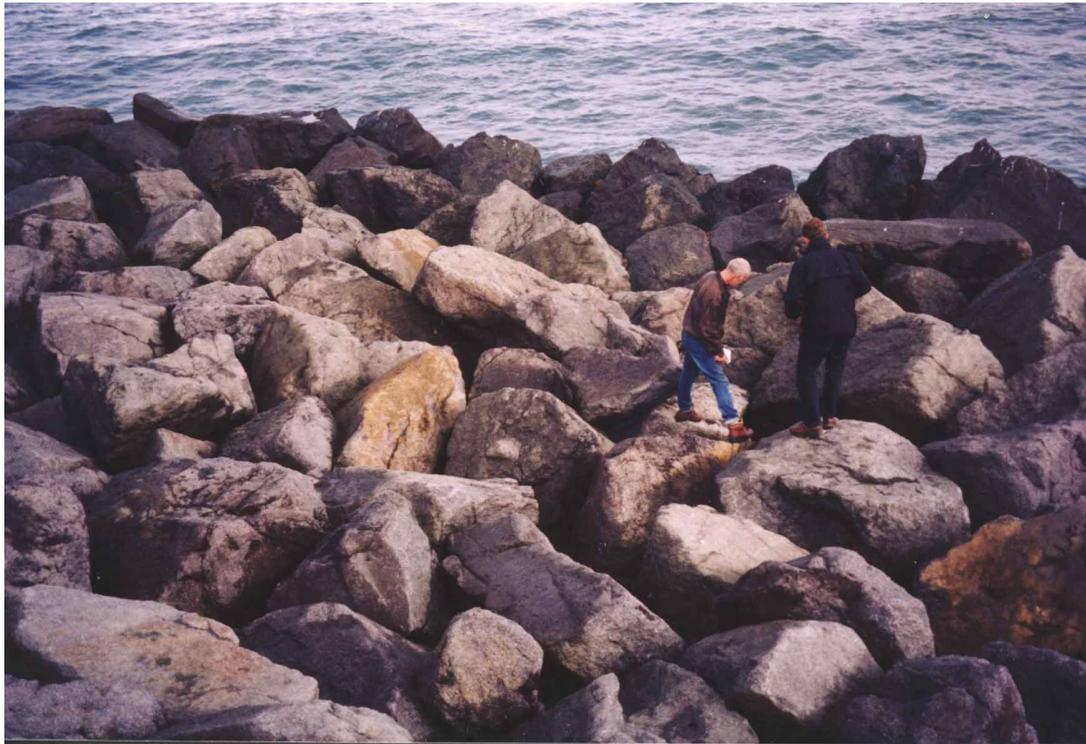
Figure 2. No construction unit is as far from being standardised as the armourstone in the primary cover layer with regard to form, strength and durability. Basalt stones in the Bolungarvik berm breakwater. A large part of the stones has some unopened cracks or geological flaws.

Figure 2. No construction unit is as far from being standardised as the armourstone in the primary cover layer with regard to form, strength and durability. Basalt stones in the Bolungarvik berm breakwater. A large part of the stones has some unopened cracks or geological flaws.

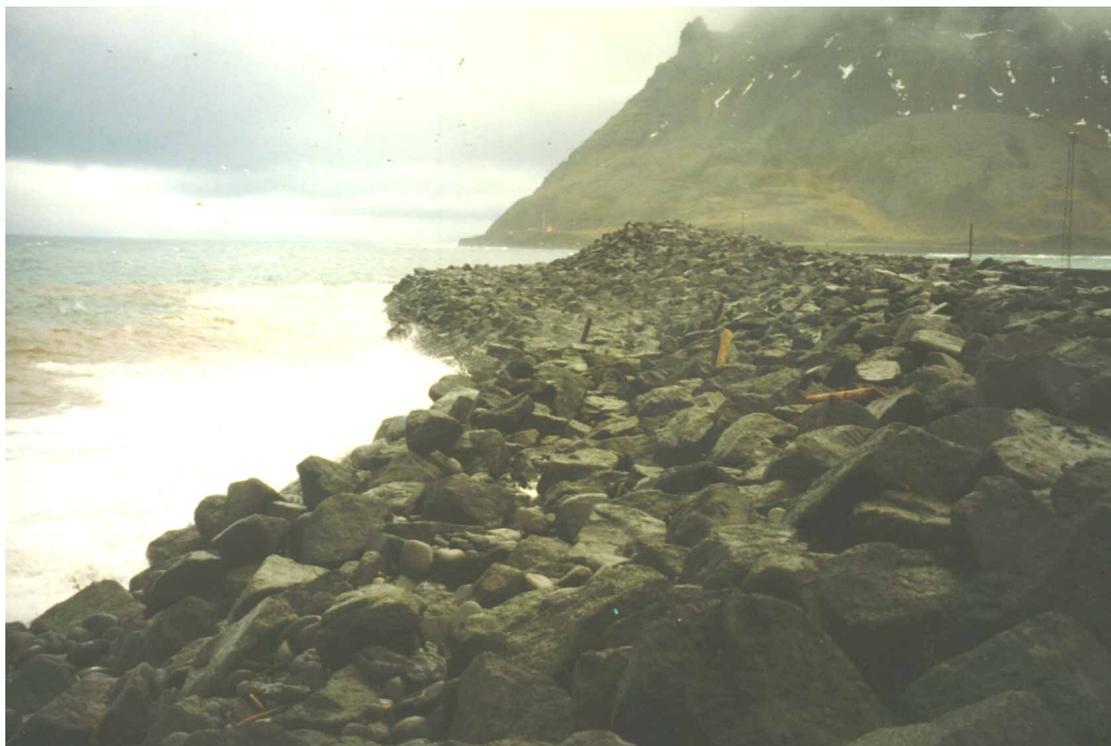
Figure 3. The statically stable non-reshaping Bolungarvik berm breakwater after having experienced design storm lasting for at least two days in January 1995.

Many of the Icelandic berm breakwaters fall into the category of statically stable non-reshaping structures, with none or only minor profile changes. These are structures like the Bolungarvik berm breakwater in Iceland built in 1993. In 1995 it was exposed to a design storm lasting for two days. Monitoring of the breakwater showed that only few stones had moved from the edge of the berm in two places, Figure 3. The Sirevåg breakwater in Norway falls into the same category, with only a few stones on the entire structure having been moved from their original position after a storm exceeding the design conditions.

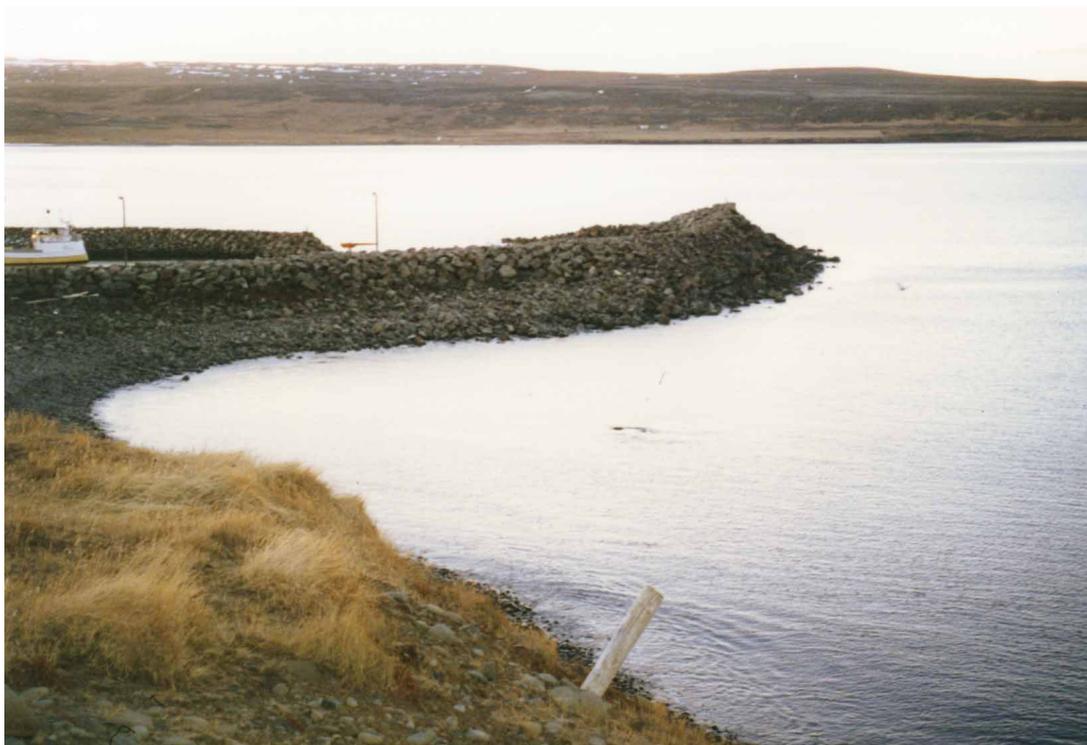
Figure 4. The dynamically unstable Bakkafjordur breakwater after the storm of October 1995 with erosion up to the crest.

The Bakkafjordur breakwater in Iceland is, on the other hand, an example of a breakwater that became dynamic unstable reshaped structure with reshaping reaching the centreline of the breakwater crest (Einarsson et al, 2002). The berm breakwater was built in 1983-1984 partly of 0.5 to 6 tonnes stones and partly of 2 to 6 tonnes stones of rather poor quality quarried at the breakwater site. Deterioration of stones on the berm accelerated the dynamic development of the profile. After a storm in 1992 the breakwater was heavily reshaped and repaired the year after by stones from the same quarry as before. In 1995 the breakwater was exposed to wave conditions in 1995 close to the design wave height of $H_s = 4.8$ m with $T_p = 12$ s. The berm was eroded up the crest and an unstable S-profile had developed, Figure 4. Video recordings show waves breaking in front of and on the breakwater. Inspection of the reshaped profile showed that deterioration of the stones had caused plugging of the voids and the structure did not function as a berm breakwater, resulting in higher forces on the slope and high wave overtopping. The year after the breakwater was repaired with two layers of stones of 4 to 10 tonnes with a slope of 1 to 3 on the top of the reshaped profile and with about 3 stones above 10 tonnes in front of the two layers from elevation -2 to $+2$ m. These stones were taken from another quarry further away and were of much better quality than the original berm.

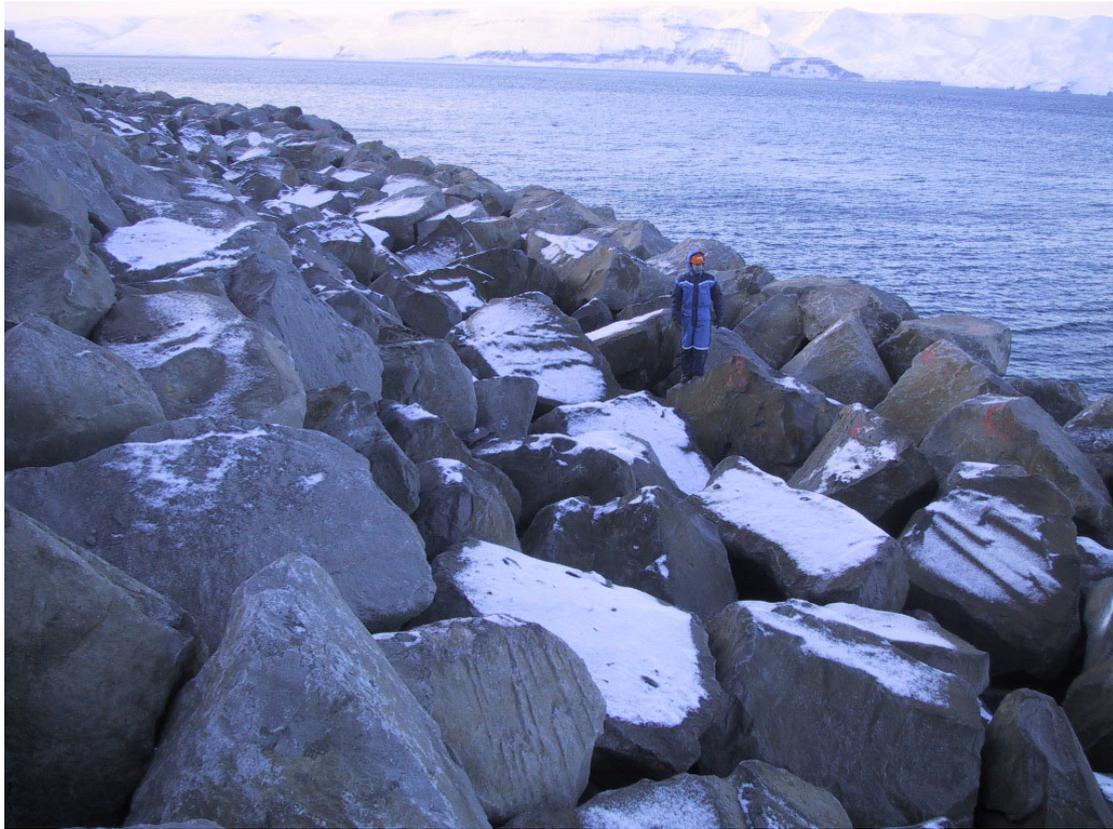
Figure 5. Narrowly graded stones on the Husavik berm breakwater. Class II, 10 to 16 tonnes, in the foreground and class I, 16 to 30 tonnes, further away.

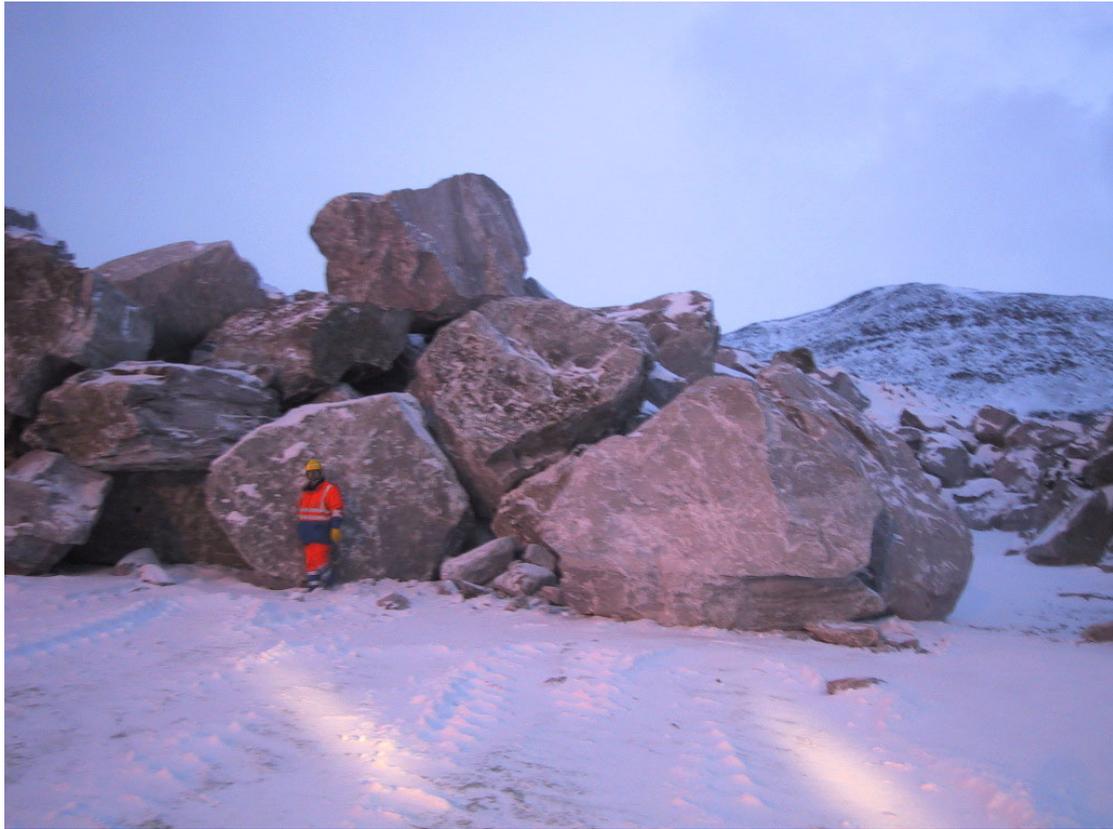
Figure 7. Stock pile of class I stones, 20 to 35 tonnes, in the Hammerfest LNG terminal, with a quarry yield of about 5%. During the construction period from autumn 2002 to spring 2003 2.3 million m³ of rock was quarried.

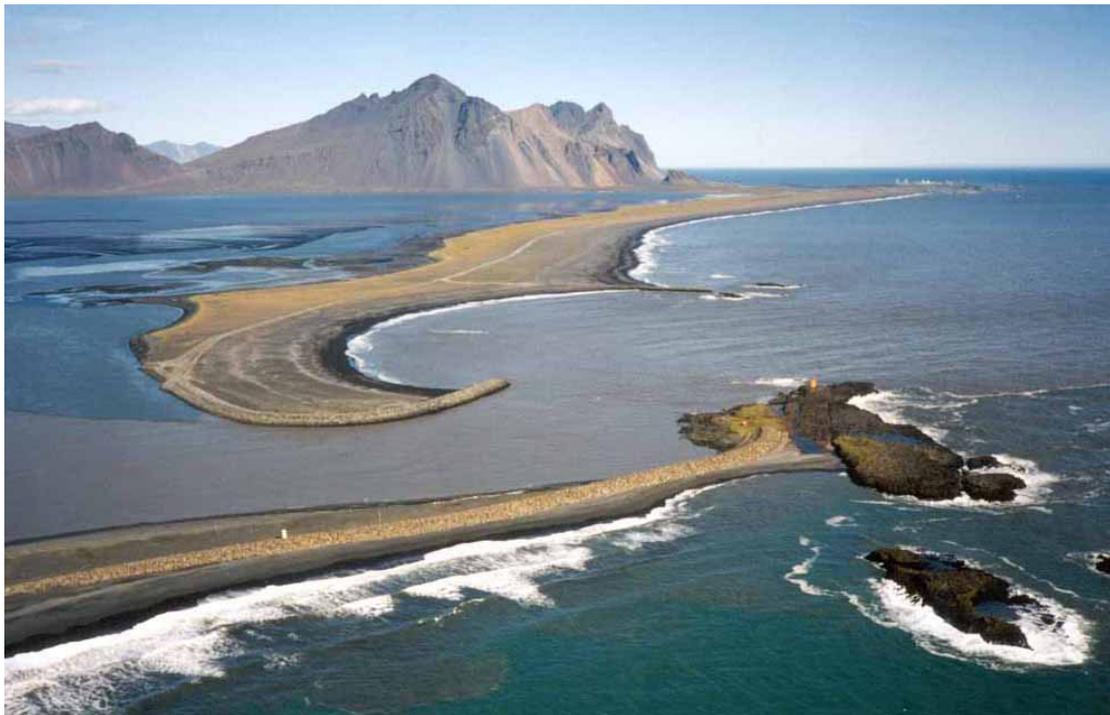
Figure 8. The stabilised Hornafjordur tidal inlet with the shore protection on the S-barrier in the foreground, built in 1991, the curved berm jetty in the centre of the photo, built in 1995, and the weir to the skerries to the right and above the jetty, built in 2000.

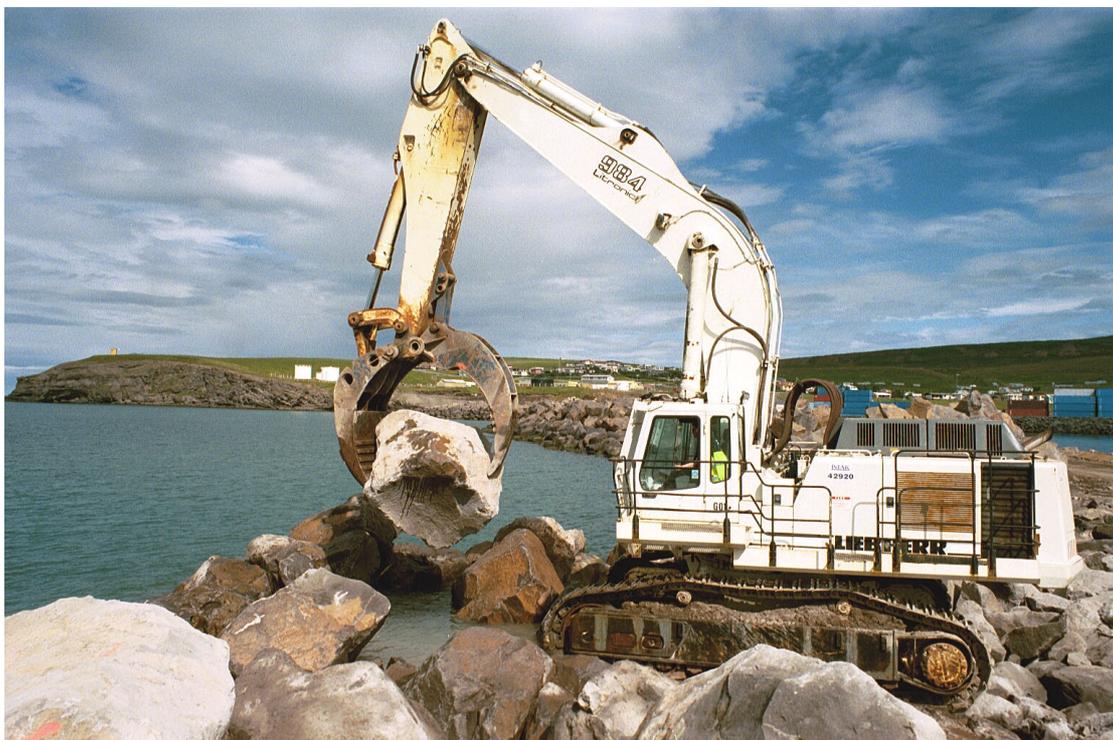
Figure 9. Placing of class I stones, 16 to 30 tonnes, in the head of the Husavik berm breakwater.

Usual equipment includes a drilling rig, two or more backhoe excavators, one or more front loaders, and some trucks depending on the hauling distance and size of the project. Backhoe excavators with open buckets or prong are used to place stones. In projects with maximum stone size up to 10 to 15 tonnes it is usual to use backhoe excavators of 40 to 50 tonnes, with maximum stone size up to 20 to 25 tonnes 70 to 80 tonnes backhoe excavators are used and where maximum stone size is 30 to 35 tonnes excavators up to 110 to 120 tonnes are used, Figure 9.

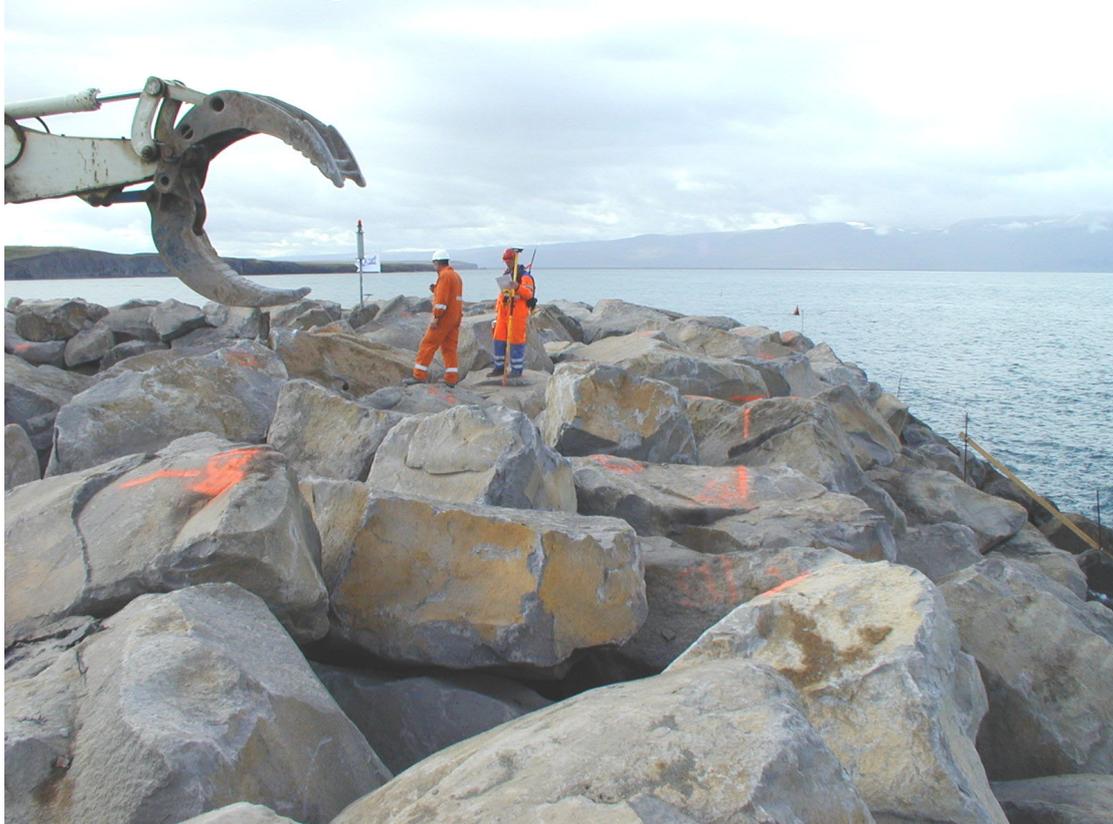
Figure 10. Surveying of the class I stones, 16 to 30 tonnes, on the berm at trunk and head sections before building the crest structure of the Husavik berm breakwater.

Tolerance for the placement of stones on berm breakwater is greater than for conventional breakwater and less strict placing techniques is needed. Usually no careful underwater placement is necessary. The front slope is steep and stones can be dropped or thrown by backhoe excavators or cranes. Placement of stones, up to 5 tonnes, in a slope of 1:1.3 has been achieved down to 8 -10 m water depth with 40 to 50 tonnes backhoes. In the Sirevåg breakwater a 110 tonne backhoe was used to place stones of up to 20 tonnes down to -7.0 m water depth and up to stones of 30 tonnes down to -1.0 m. Good interlocking of carefully placed stones is, on the other hand, specified at the front above low water and up to the edge of the berm, Figure 10.

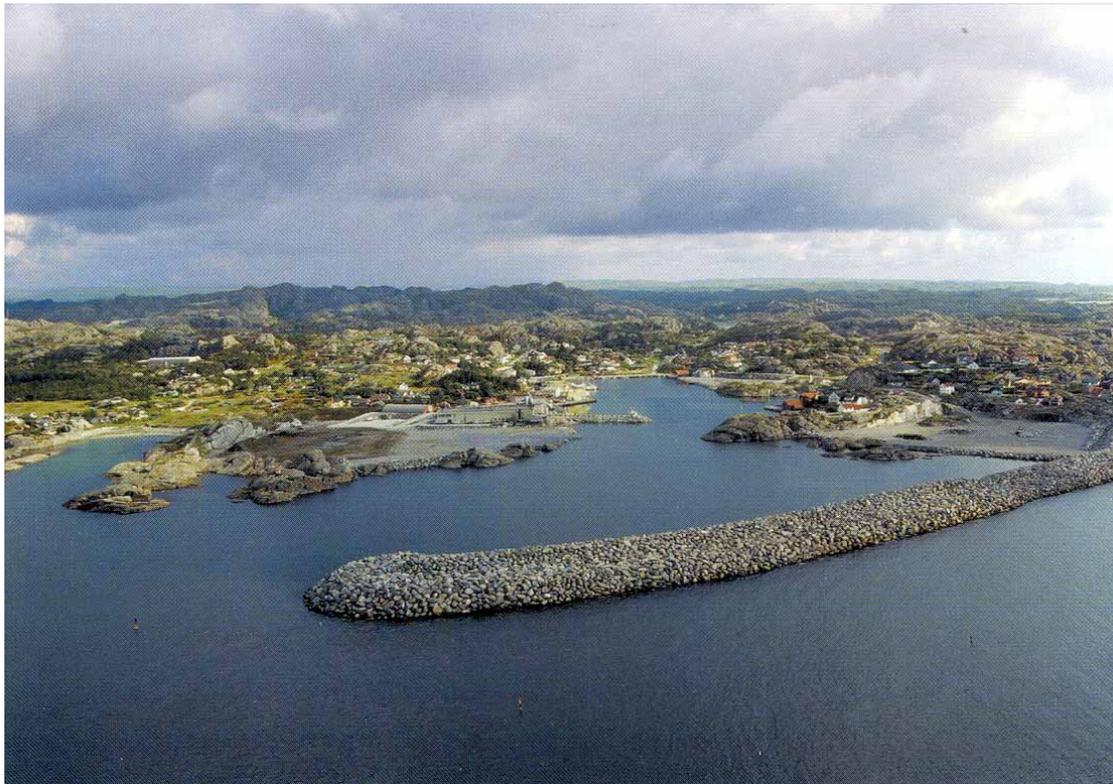
Figure 13. The Sirevåg breakwater was finished in July 2001 three months ahead of schedule.

The construction of the Sirevåg berm breakwater started in March 2000 and was finished in August 2001, 3 months ahead of schedule, without any claims from the contractor, Figure 13.

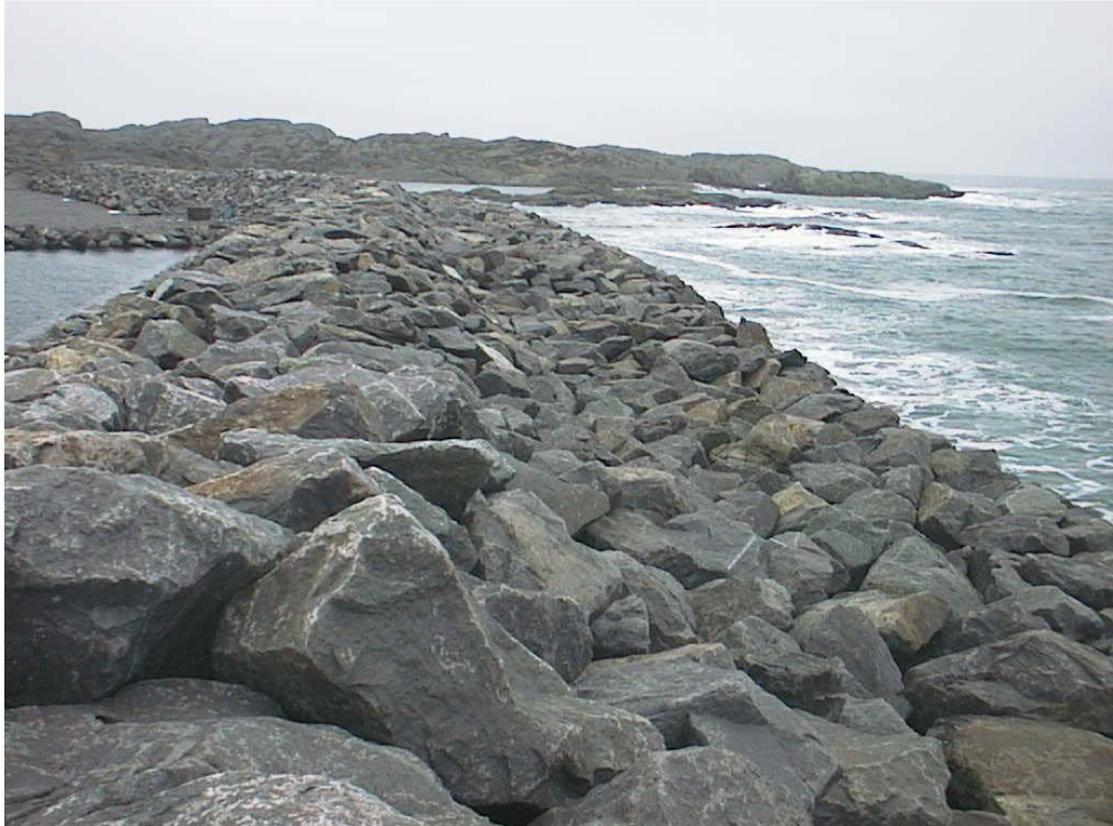
Figure 14. The Sirevåg breakwater after the storm in January 2002.

The Sirevåg breakwater was hit by a severe storm on January 28, 2002. A Waverider buoy located 200 m off the breakwater head measured wave heights at half an hour interval. Max recording during the storm was $H_s = 9.75$ m. SINTEF has analysed the measurements and the wave height exceeded $H_s = 8.5$ m for a duration of 3 hours. The reduction of wave height from buoy to the front part of the breakwater and the breakwater head is 12% according to SINTEF's refraction analysis, which corresponds to $H_s = 7.5$ m at the front part of the breakwater, well above the design wave of $H_s = 7.0$ m. The breakwater survived the storm without any reshaping, and only a few stones were moved from their original location, Figure 14.
