## ARMOURSTONE FOR THE ICELANDIC-TYPE BERM BREAKWATER

S. Sigurdarson<sup>1</sup>, R. Mocke<sup>2</sup>, M. Primmer<sup>3</sup> and S. Gretarsson<sup>4</sup>

**Abstract:** This paper discusses the design concept of Icelandic-type berm breakwater and the key differences in the use of armourstone compared with mass armoured breakwater designs. Through reference to two breakwater case studies, a comparison has been provided on the damage performance of each design when exposed to wave conditions up to and exceeding the design event.

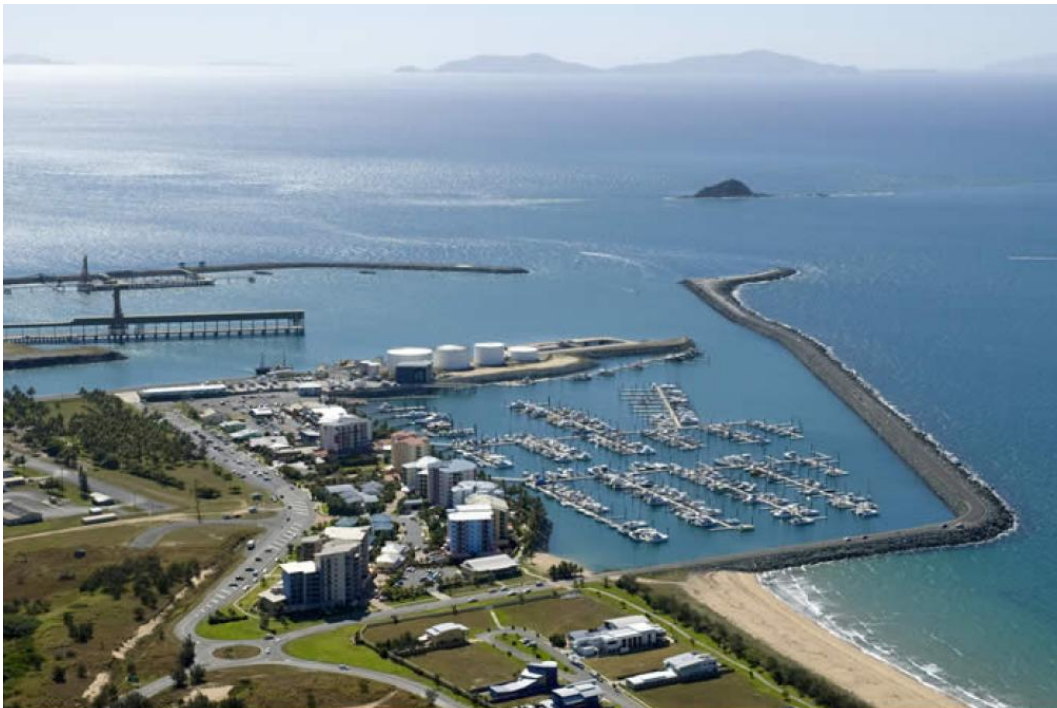
Figure 1. Mackay harbour, the Small Craft Harbour breakwater to the right on the photo protecting the marina, from NQBP (2011).

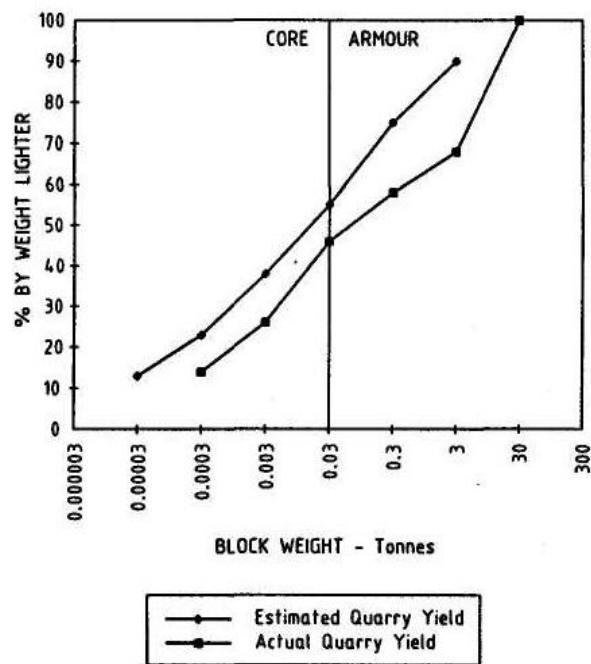
**Figure 2. Grading curves for estimated and actual quarry yield for the Mackay Small Craft Harbour breakwater, from Johnson et al. (1999).**

The breakwater is built with rock from the Mt Basset Quarry that has been used for construction and maintenance of breakwaters in Mackay since the 1930's. In the design phase of the Small Craft Harbour breakwater, a surface and subsurface quarry investigation was undertaken to determine the potential quarry yield in terms of blast block size distribution and to assess rock quality, Johnson et al. (1999). The design of the breakwater required an optimum yield of about 50% armour and 50% core and the adopted block size distribution separated armour and core at 30 kg, with armour heavier than 30 kg and core weighing less than 30 kg. Figure 2 shows the grading curves for the estimated and actual quarry yield

As shown in Figure 2, the actual yield turned out to be considerably better than the predicted yield. Prior to construction, it was estimated that less than 10% of the quarry yield would exceed 3 tonnes, and this was also the largest rock size shown on the quarry yield curve. During the quarry development, in fact, the actual quarry yield above 3 tonnes was over 30% with armourstone weighing up to 30 tonnes. In addition, the median weight of the armour is close to 3 tonne, as estimated from the grading curve.

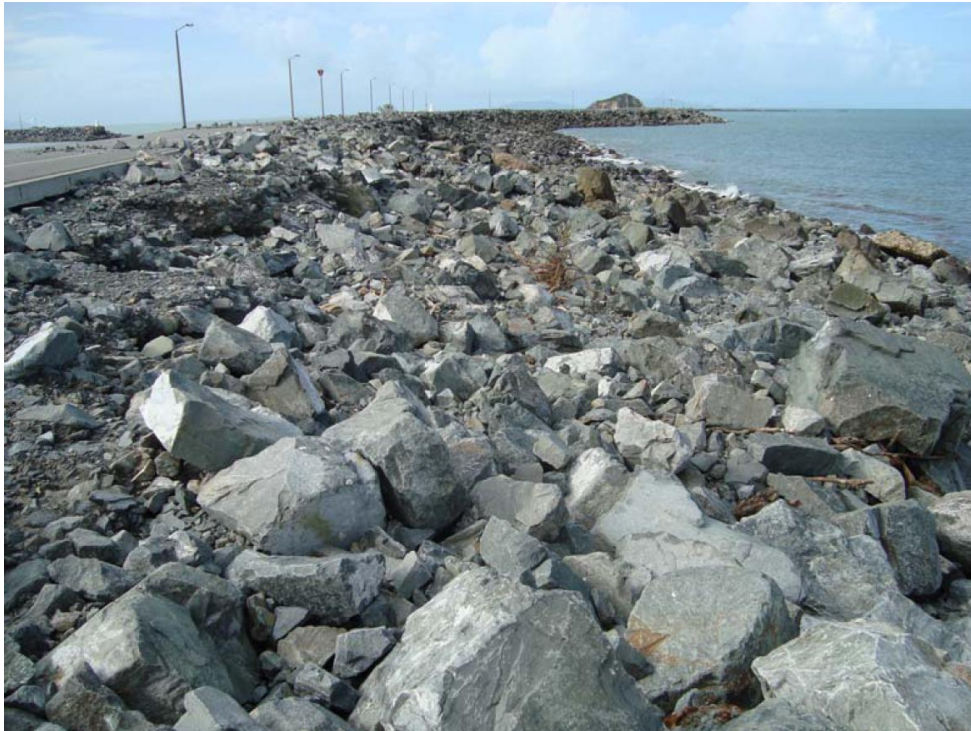
**Figure 4. The Mackay Small Craft Harbour breakwater after the Tropical Cyclone Ului, from Colleter et al. (2011).**

During the Tropical Cyclone Ului in March 2010, the breakwater was significantly damaged and substantial wave overtopping occurred, Colleter et al. (2011). At the peak of the storm, the significant wave height along the breakwater varied between  $H_s=4.0$  and 4.3 m. The reshaping extended well into the crest section with the bitumen road on top of the breakwater damaged in areas. Rock up to 0.5 and 1.0 tonne was left on the crest and the inner harbour revetment was damaged by overtopping flow. After the storm the median rock mass on the emerged reshaped slope was estimated as 1.5 tonne with significant variations along its length. This corresponds to a stability number at the peak of the storm of  $H_s/\Delta D_{n50} = 3.0$  to 3.2.

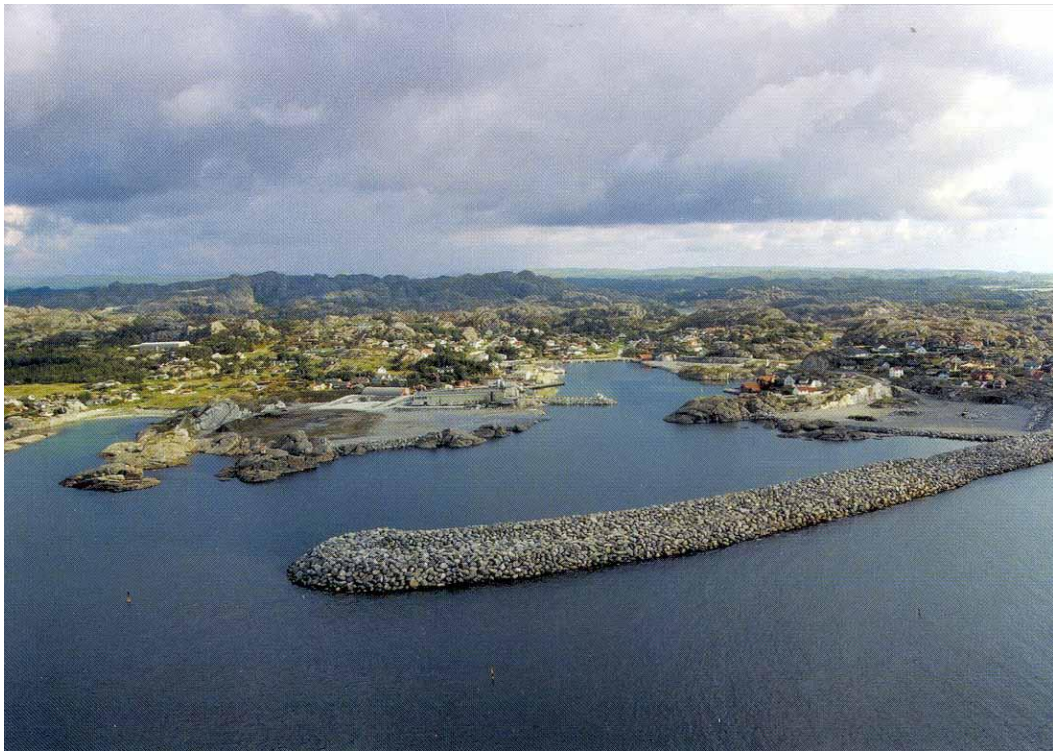
Figure 5. The Sirevåg berm breakwater.

The Sirevåg breakwater is located in a narrow bay on the west coast of southern Norway and was constructed in the period from January 2000 to July 2001, Figure 5, Sigurdarson et al. (2001) and (2003). The breakwater was designed and constructed as a partly reshaping Icelandic-type berm breakwater for a wave height with a 100-year return period. It should also withstand a wave height with 1000-year return period without total damage.

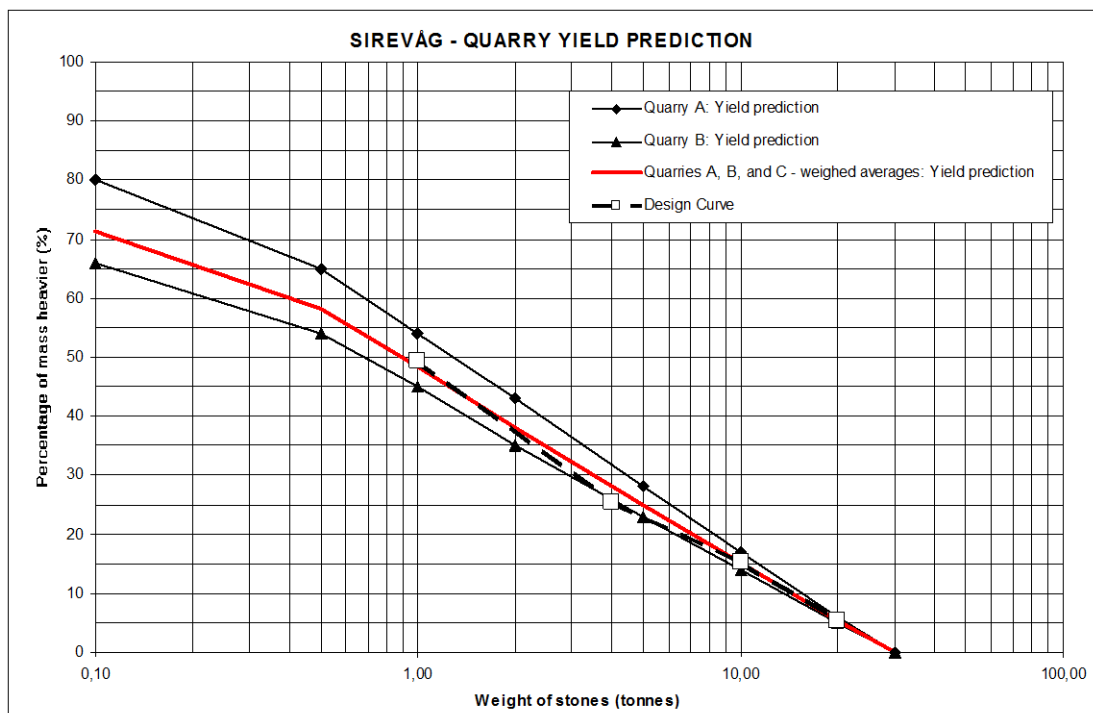
Figure 6. Quarry yield prediction and design curve for the Sirevåg breakwater.

The quarry investigations included drilling of 25 cored drill holes and surface scan-lines. Three possible quarries (A, B and C) all from the same rock formation were assessed for the Sirevåg breakwater. A quarry yield prediction was carried out for the three quarries for a 640,000 m<sup>3</sup> breakwater. The armourstone material is anorthosite gabbro rock of good quality with specific gravity (SSD) of 2.7 t/m<sup>3</sup> and water absorption between 0.2 and 0.3. The point load index exceeds 10 MPa. The quarry yield prediction, Figure 6, for a carefully worked quarry was about 30% over 3 tonnes.

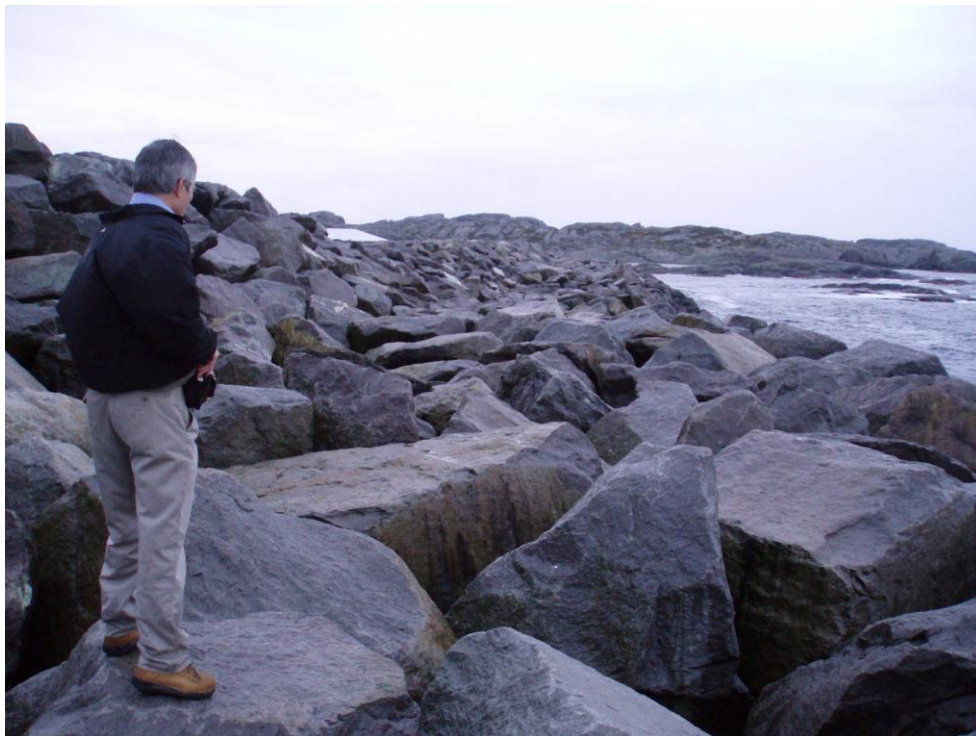
**Figure 8. Inspection of the Sirevåg breakwater after being twice exposed to design wave conditions.**

During a site visit to the Sirevåg breakwater in September 2008, the breakwater was inspected (see, Figure 8). The outer part of the breakwater and the roundhead suffered recession which was quite more extensive than after the 2002 storm. The recession has been estimated from an aerial photo, Sigurdarson et al. 2009. On the breakwater trunk the maximum recession is of the order 2.1 to 6.2 m. With a mean diameter of Class I armour stones of 2.05 m. this corresponds to a recession of about 1 to  $3 \cdot D_{n50}$ . On the breakwater head the maximum recession is about 8.4 m which corresponds to about  $4 \cdot D_{n50}$ .
